Ground Penetrating Radar as a Sentinel Device

The Hutchinson Group, Ltd.

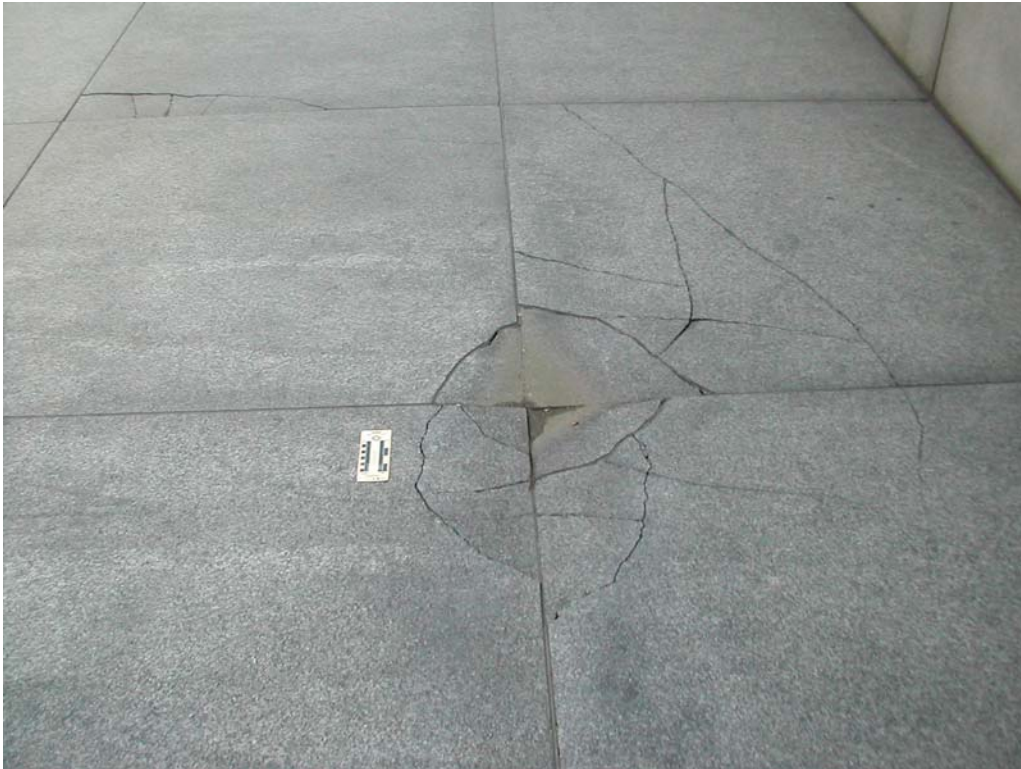
Figure 2: Deformation of the expensive granite pavers due to subsidence of the fill materials (plastic scale is 1 foot).

Unfortunately, 15 years later the sand, cement/grout layer and pavers have subsided in many areas (Figure 2). The cost of the removal of the pavers and/or replacement of the pavers coupled with the cost of rehabilitating the subsurface was costing over \$100,000 each event. Building management was keen to find a solution that would fit into a manageable budget since broken 4-ft by 5-foot granite pavers cost \$4,000 to replace and the risk of injuries to pedestrian traffic was unacceptable.

An investigation was conducted using a three-dimensional time-depth GPR mapping strategy to determine areas of potential subsidence. Fifteen areas were identified as having voids at depths associated with the loss of sand subgrade and collapse of the grout/concrete layer into the void (Figure 2). The loss of the sand subgrade may be related to poor placement of the sand or flushing of the sand from between the soldier piles and the outer wall of the former excavation. Nevertheless, these 15 areas in question were rehabilitated at great expense and building management required a sentinel strategy to minimize future cost and prevent injuries related to subsidence.

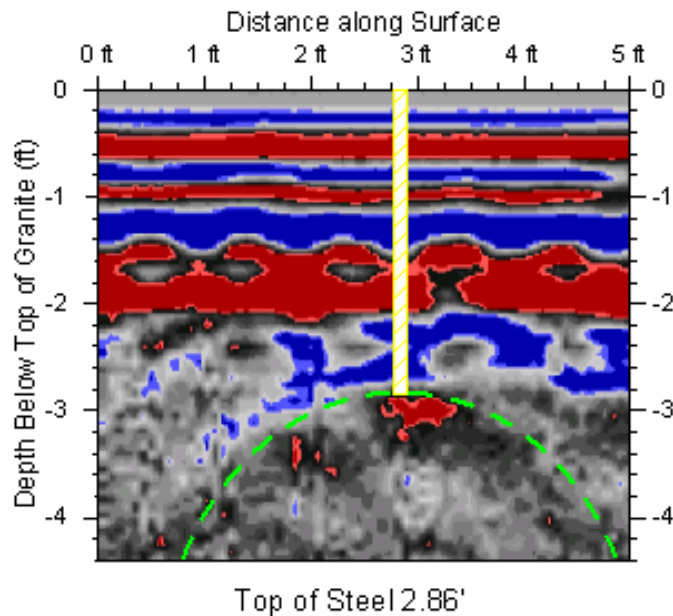
Figure 4: Ground penetrating profile image showing the diffraction pattern from the top of the solid steel cylinder.

After completion of the installation of 44 sentinel devices in the 15 rehabilitated areas and 29 other areas along 1,000 feet of sidewalk, ground penetrating radar images were collected over the sentinels (Figure 4). The time-depth to the top of each bar was noted on the 2-way time profile from the GPR image. The velocity was determined using the measured placement depth to the top of bar and the 2-way time to the top of the bar. The velocity was recorded and will be used for each sentinel event to determine the depth to the top of each bar. An increase in the depth to the top of the bar is considered to be evidence of continued subsidence.
